**Preliminary Comments on Panama Cobre
Panama**

Expert Report prepared by:

Science Team, Environmental Law Alliance Worldwide

December 9, 2024

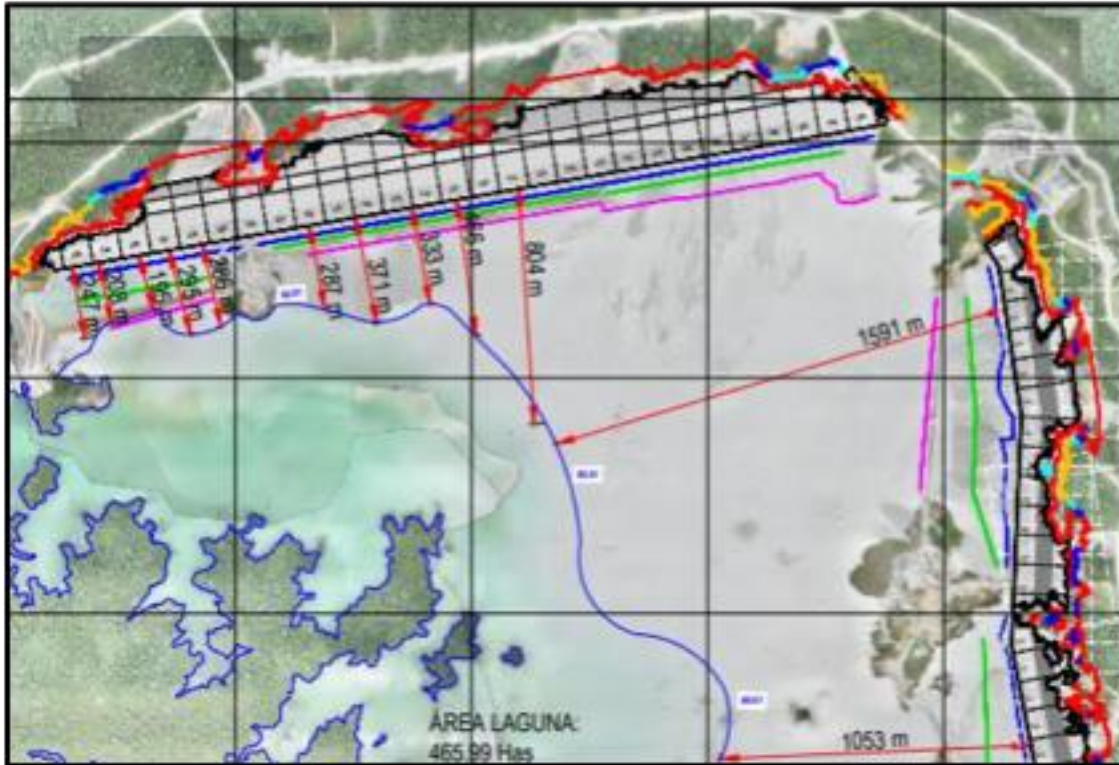
According to New Fields, the risk of failure of the North Wall of the tailings dam is because liquids in the TMF are approaching too close to the North Wall, creating the risk of erosion by seepage of liquids through the North Wall – this phenomena is referred to as “piping”. To prevent failure of the North Wall by internal erosion by this seepage pathway, liquids in the TMF should approach no closer than 400 meters to the North Wall (

Figure 1). However, in practice, liquids in the TMF are approaching as close as 195 meters to the North Bank, causing a serious risk of failure by internal erosion.

According to New Fields, the root cause of liquids in the TMF approaching too close to the North Wall is the location of the spillway, which is too close to the North Wall. According to New Fields, the solution to the problem would be to move the spillway several hundred meters to the south, which would draw liquids away from the North Wall.

Figure 1: Ortofoto del 19 de octubre del 2023 que ilustra longitudes de playa de menos de 400 m durante las operaciones (Source: New Field report May 17, 2024)

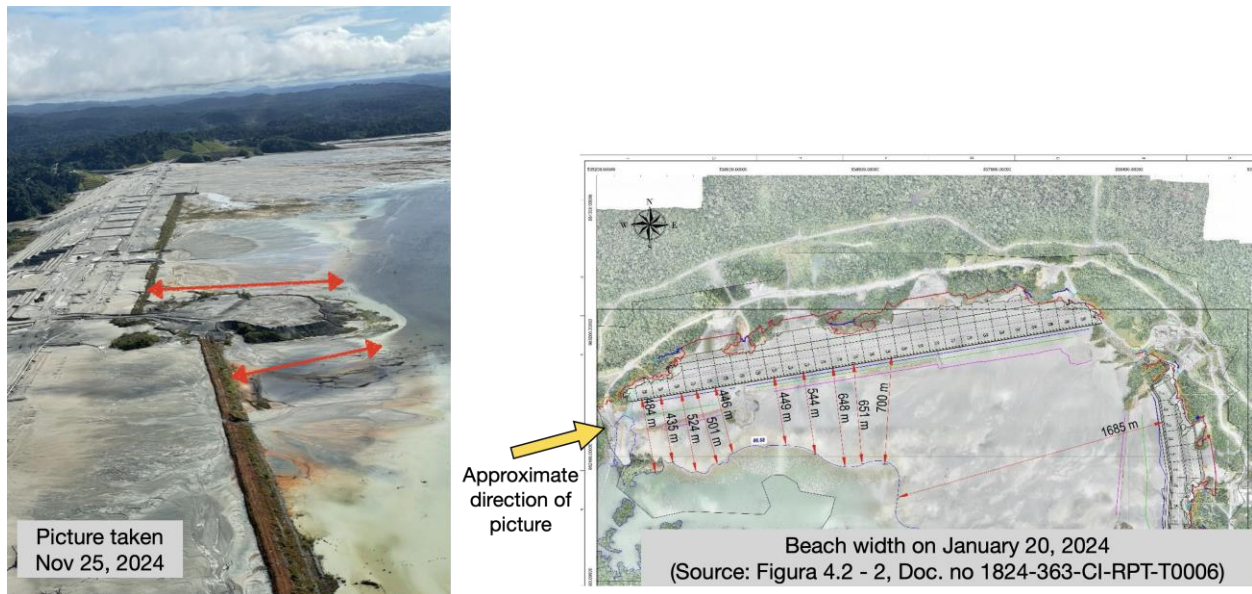
During the November 25, 2024, flight over the mine, a picture was taken showing the narrow beach (in the order of 200 m, Figure 2). This confirms the high risk of failure of the North wall (north dam).

Figure 2: Photo of beach width taken November 25, 2024, compared to ortophoto of beach width January 20, 2024

In ELAW’s view, this risk of failure of the dam, combined with its lack of monitoring caused by non-operational inclinometers is a **VERY SERIOUS and IMMEDIATE CONCERN**. This is another reason why there should not be any further delay in closing the Cobre Panamá mine. For example, one way of reducing the possibility of failure of the North Wall, aside from relocating the spillway, would be to move material (liquids and tailings) out of the TMF, perhaps to the Botija open pit. However, these are measures that are only compatible with closure of Cobre Panamá mine and are not compatible with resumption of mining activities.

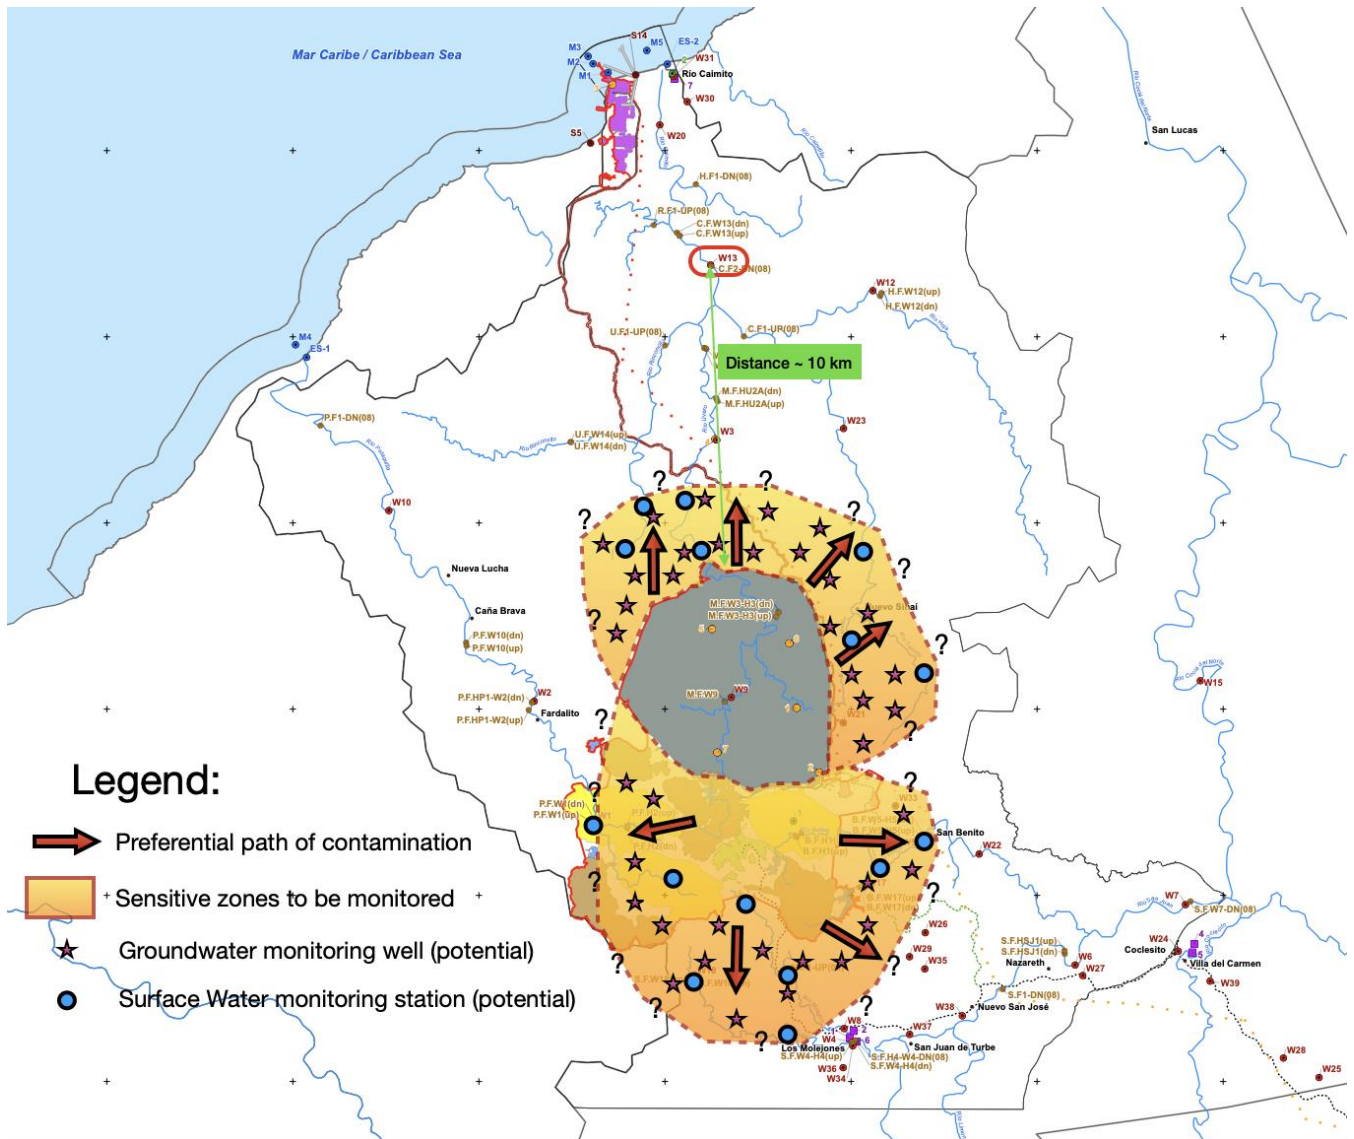
invertebrates, and aquatic habitat. Figure 3 shows areas likely impacted by contaminants where water quality should be much better monitored (locations presented for illustration only – to be defined following additional review).

Figure 3: Zones likely impacted by mining and need for improved monitoring (Modified from Map 36, Golder, June 2010)

In any case, the sulfate measurements were relatively modest compared to today’s levels at sites W-13 (See location - red circle, on Figure 3) and W-15 for example during the baseline
