In Commemoration of the Boac Spill Marinduque, Philippines, March 24, 1996

- Boac River Spill, March 24, 1996
- Calancan Bay Tailings Dumping, 1975-1991
- Mogpog River Spill, December 6, 1993

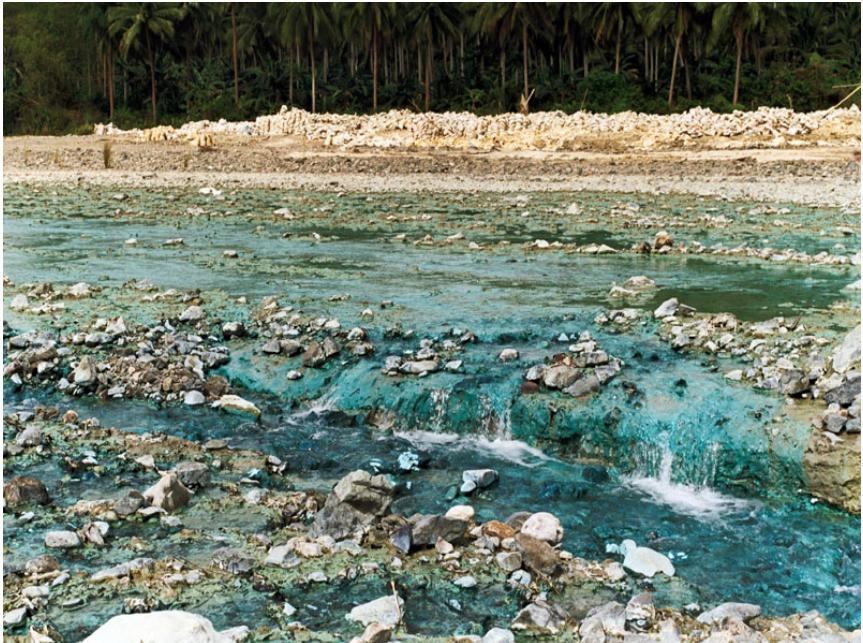
Acid-generating and metal-leaching tailings remain in disintegrating rice bags piled along the river banks. The Boac River has never been remediated.

Boac River. Oxfam Australia, 2011

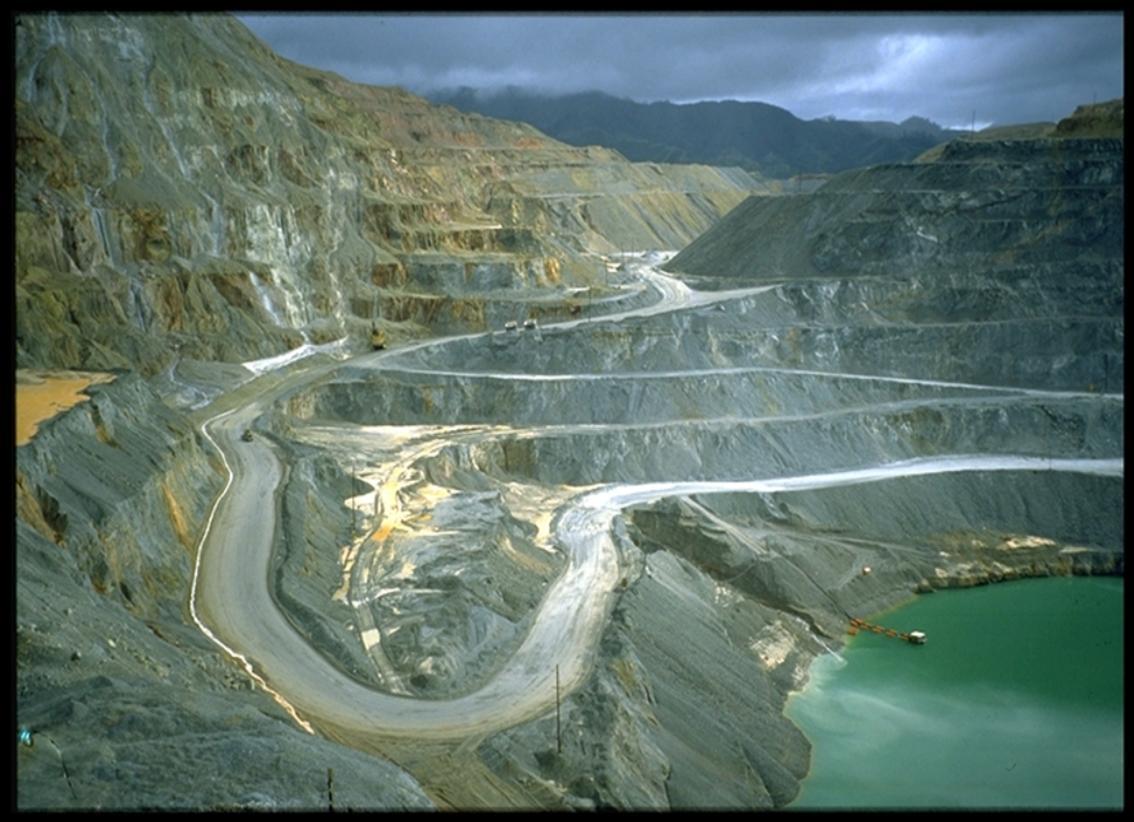
Tapian Pit. Catherine Coumans, 1989

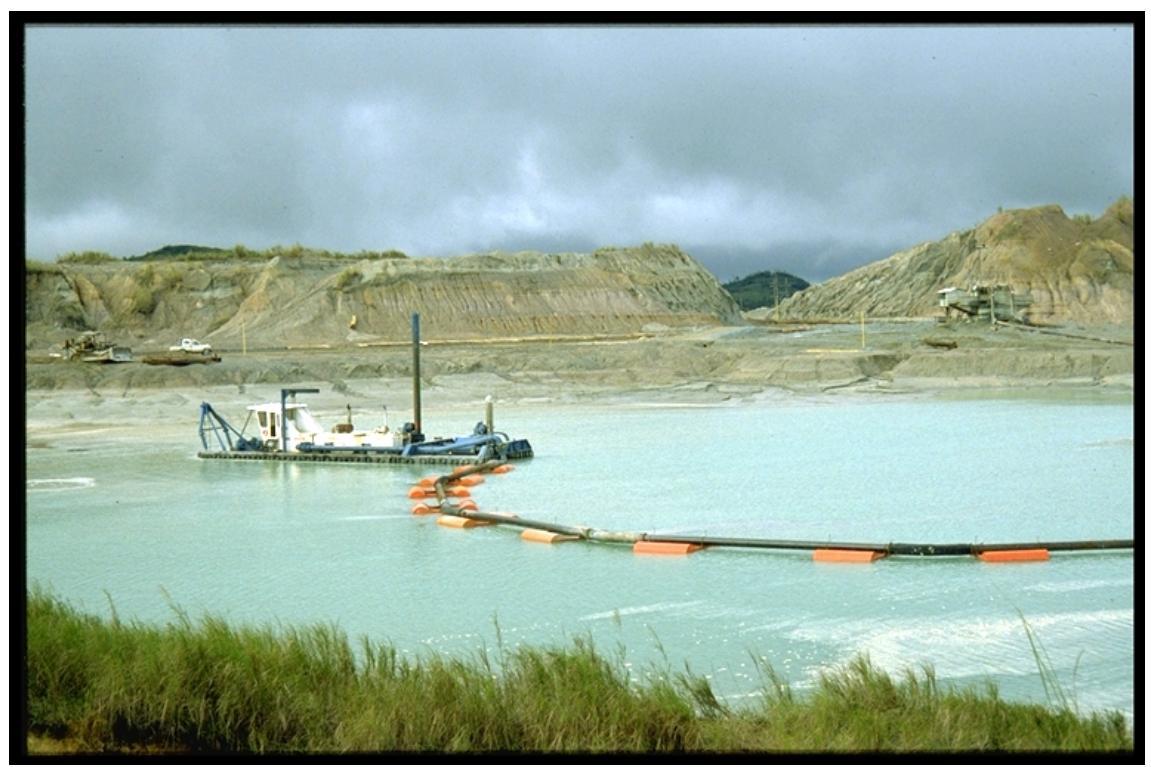
San Antonio Tailings Pond. Catherine Coumans, 1989

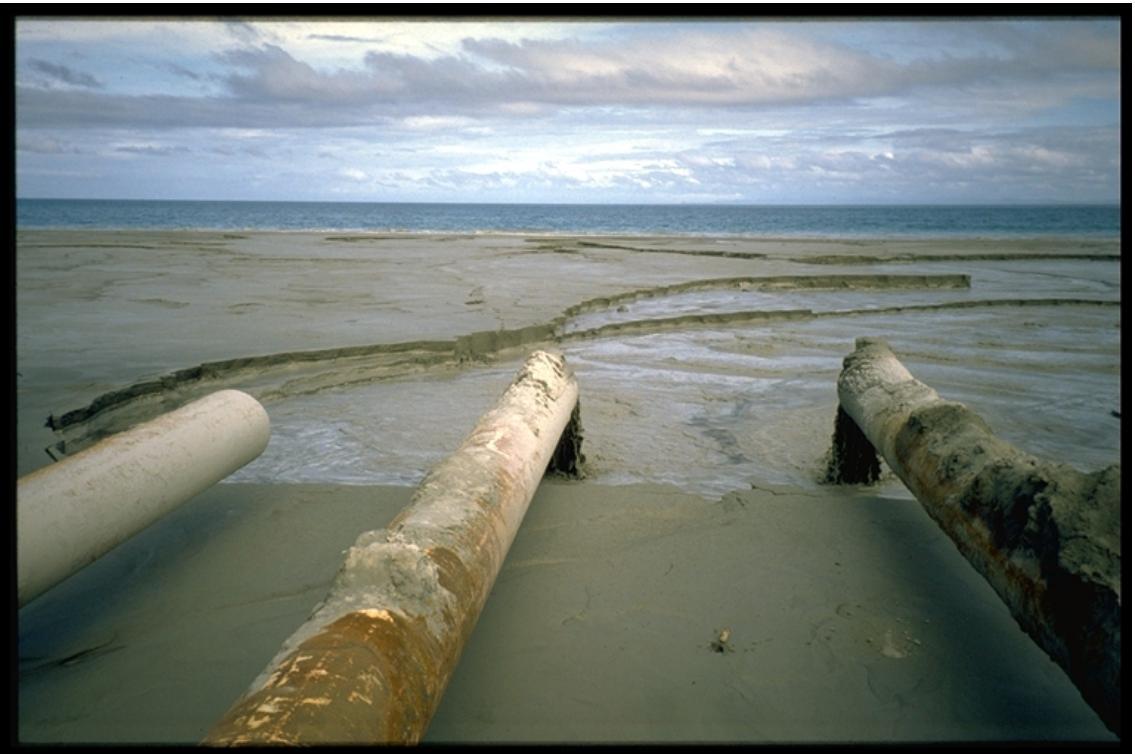
Tailings from processing of copper-gold ore from the Tapian Pit spewed into the wide and shallow Calancan Bay day and night from 1975-1991.

Over time some 200 million tons of tailings covered two major coral reefs and seagrasses over 80 square kilometres of the bottom of Calancan Bay. The tailings formed a causeway that eventually reached some 5 miles out into the sea.

Tailings from Tapian Pit entering Calancan Bay. Catherine Coumans, 1988

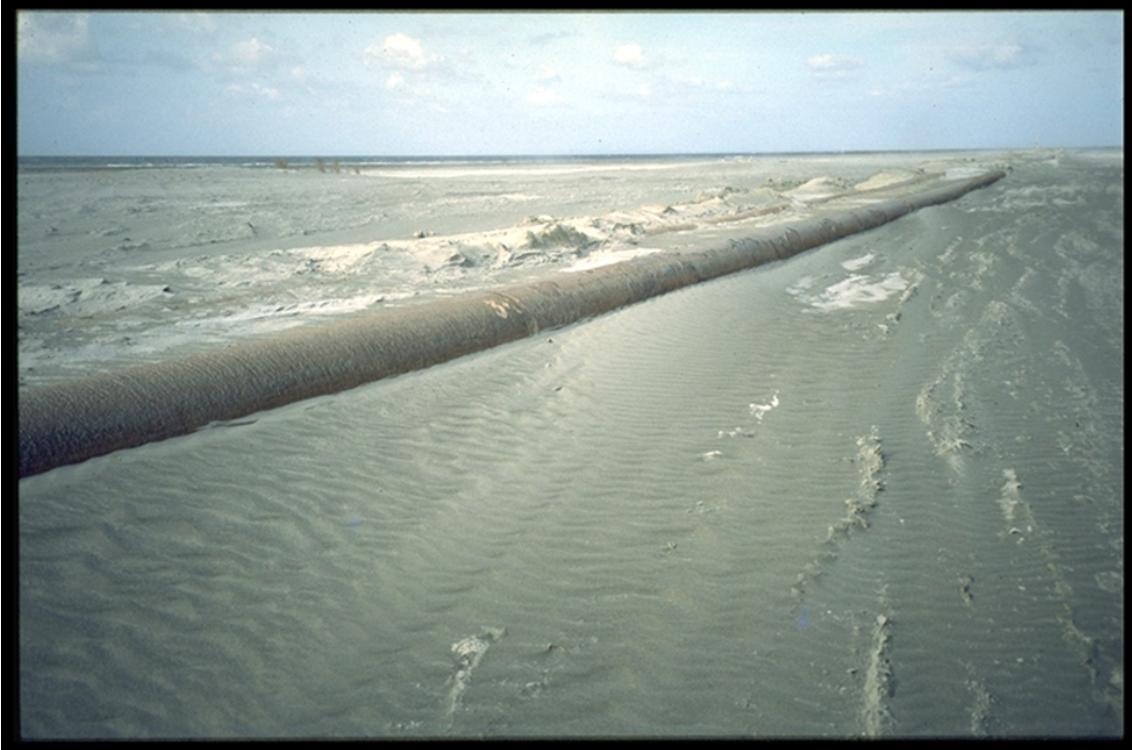
For the 16 years of dumping, and many years after that, the tailings were exposed and would regularly be stirred up by ocean breezes and blow into nearby Calancan Bay villages where they entered homes, covered rice fields and blew into open wells. Villagers called the tailings their "snow from Canada."

Calancan Bay tailings causeway. Catherine Coumans, 1988

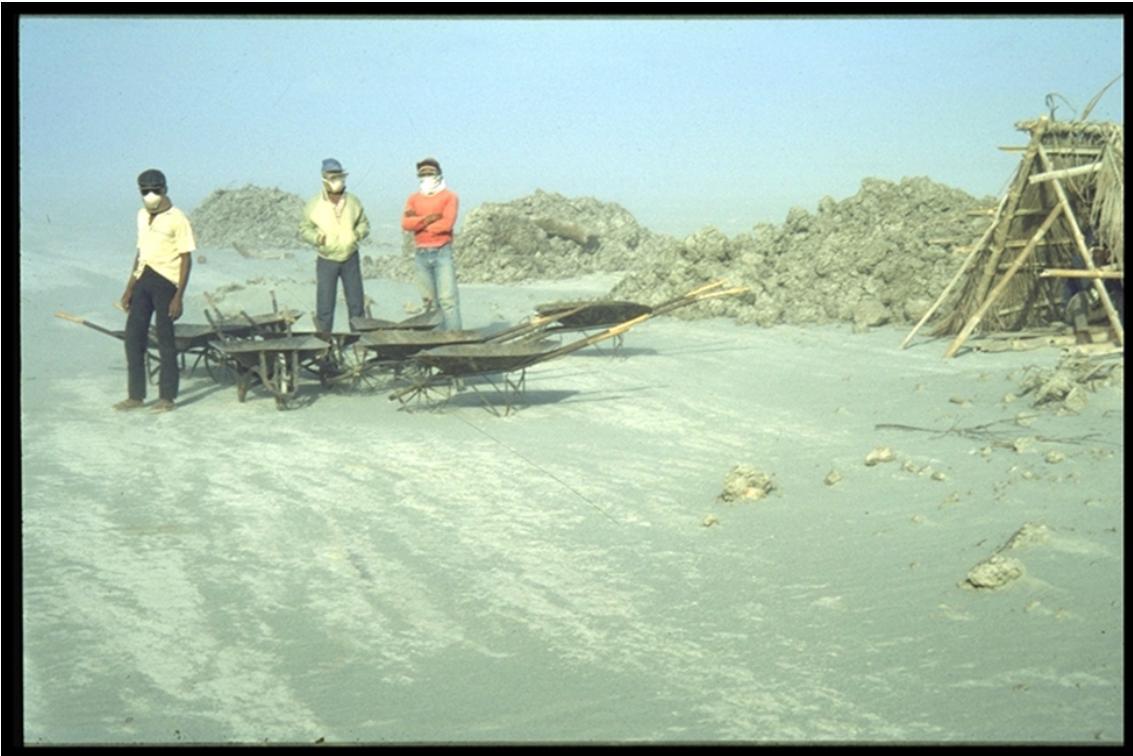
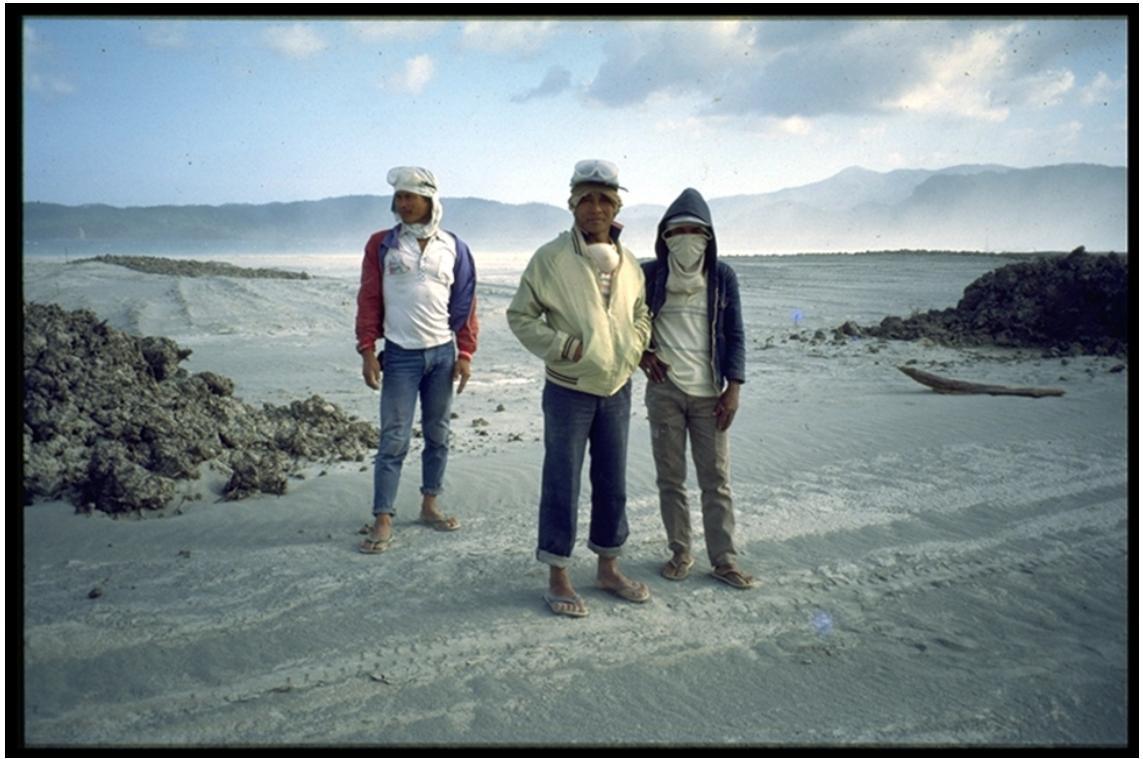
Fishermen try to spread top soil on the Calancan Bay tailings causeway. Catherine Coumans, 1988

When the second legal victory was overturned, in 1988, the company was required to hire local fishermen to spread topsoil on the tailings to try to grow vegetation and mitigate the blowing of the tailings into villages.

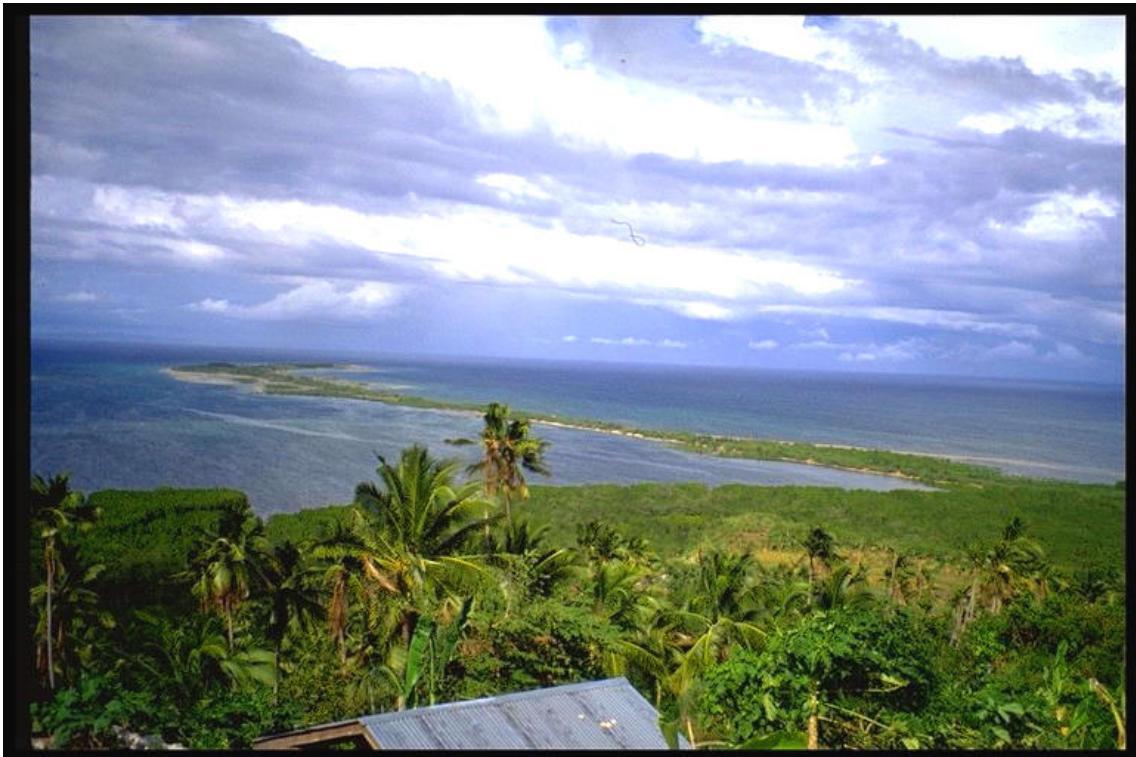
Calancan Bay tailings causeway. Catherine Coumans, MiningWatch Canada, 2001

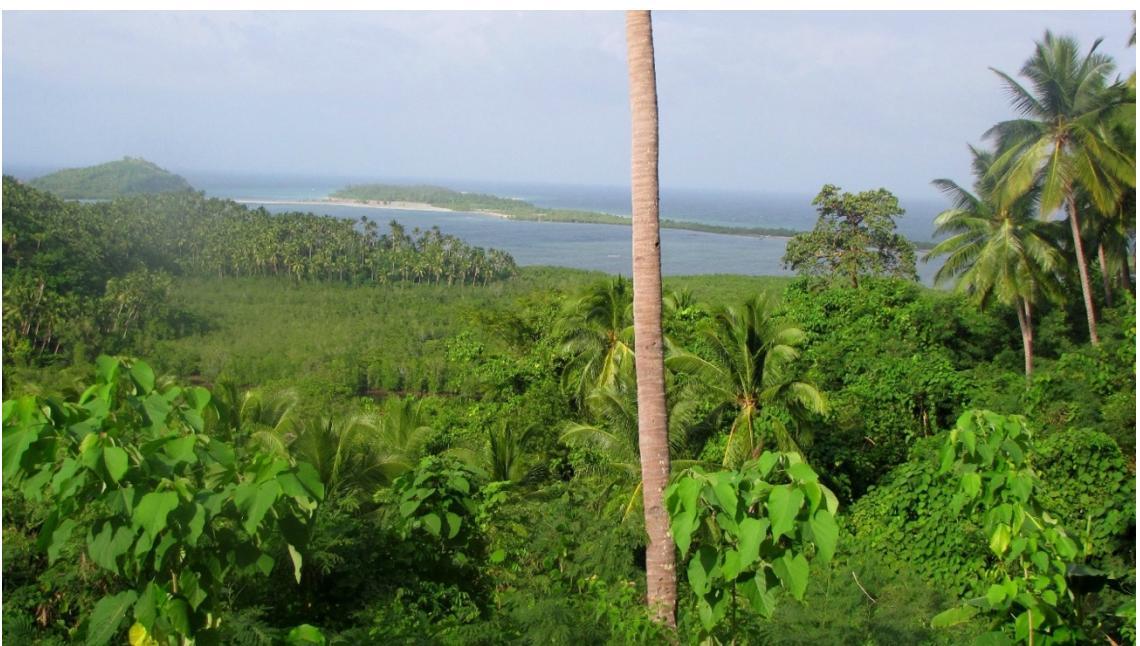
Calancan Bay tailings causeway. Catherine Coumans, MiningWatch Canada, 2016

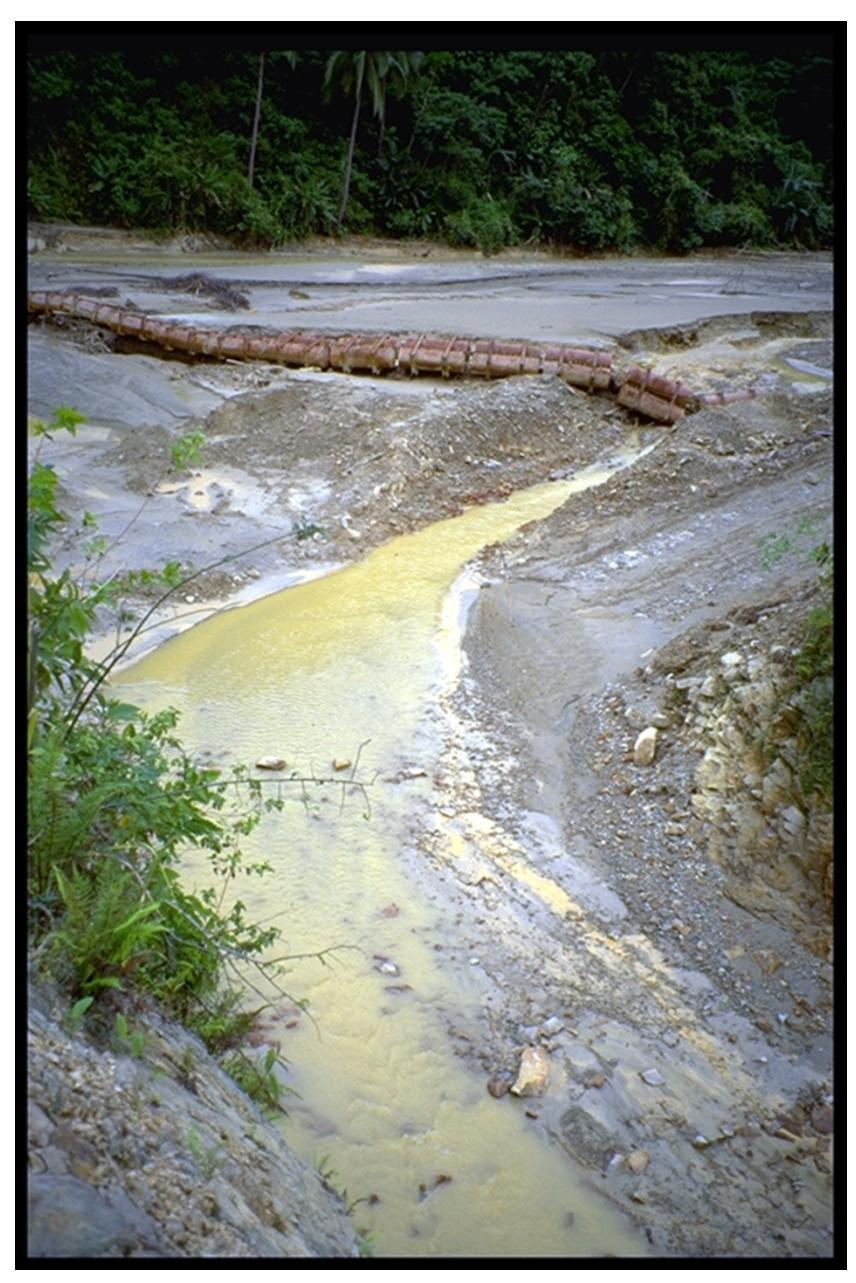
The Maguila-guila Dam was rebuilt, with an overflow this time, but the waste was soon so high behind the dam that it flowed freely through the overflow.

Waste behind the Maguila-guila siltation dam entering the overflow. Catherine Coumans, MiningWatch Canada, 2001

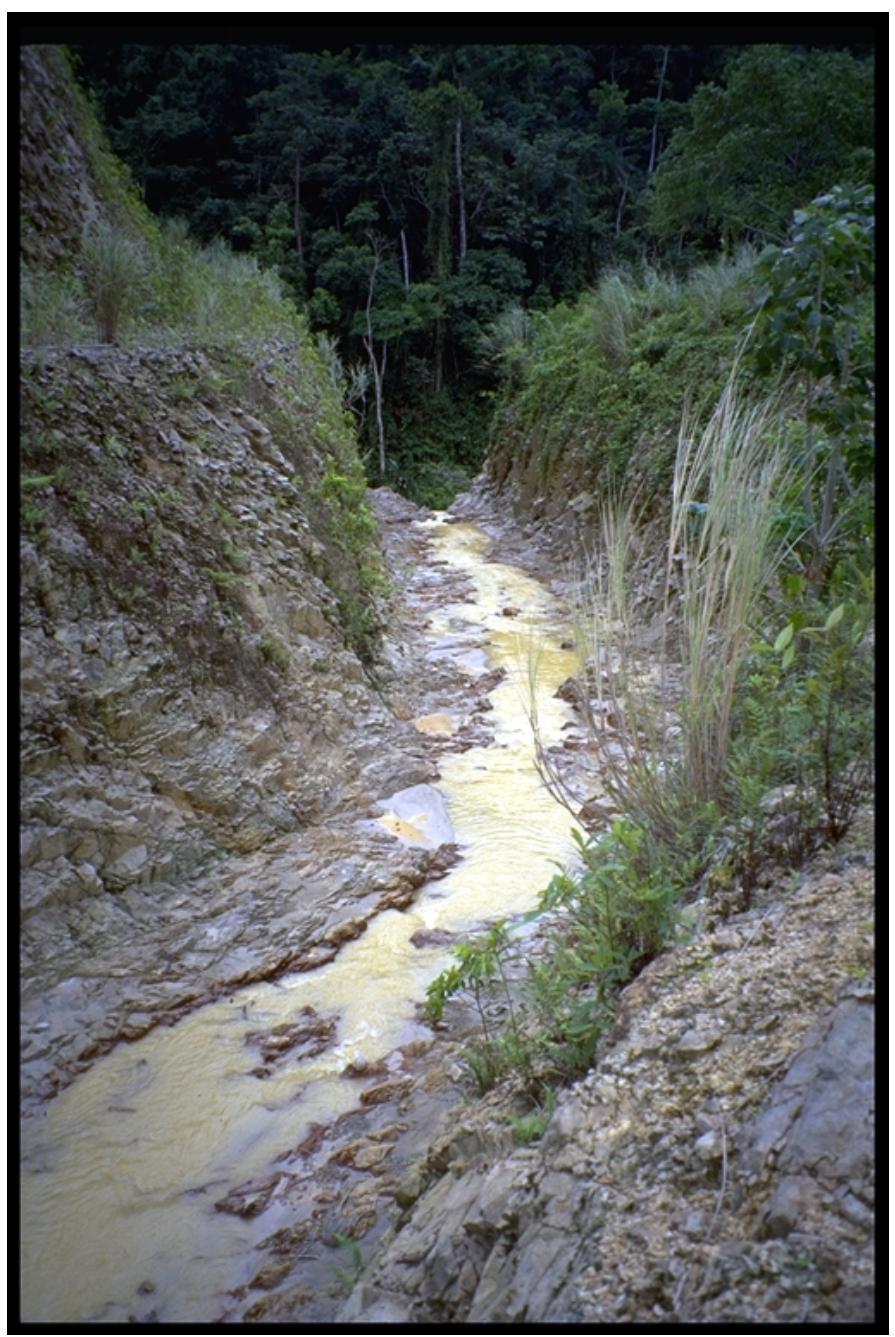
Waste behind the Maguila-guila siltation dam running through the overflow. Catherine Coumans, MiningWatch Canada, 2001

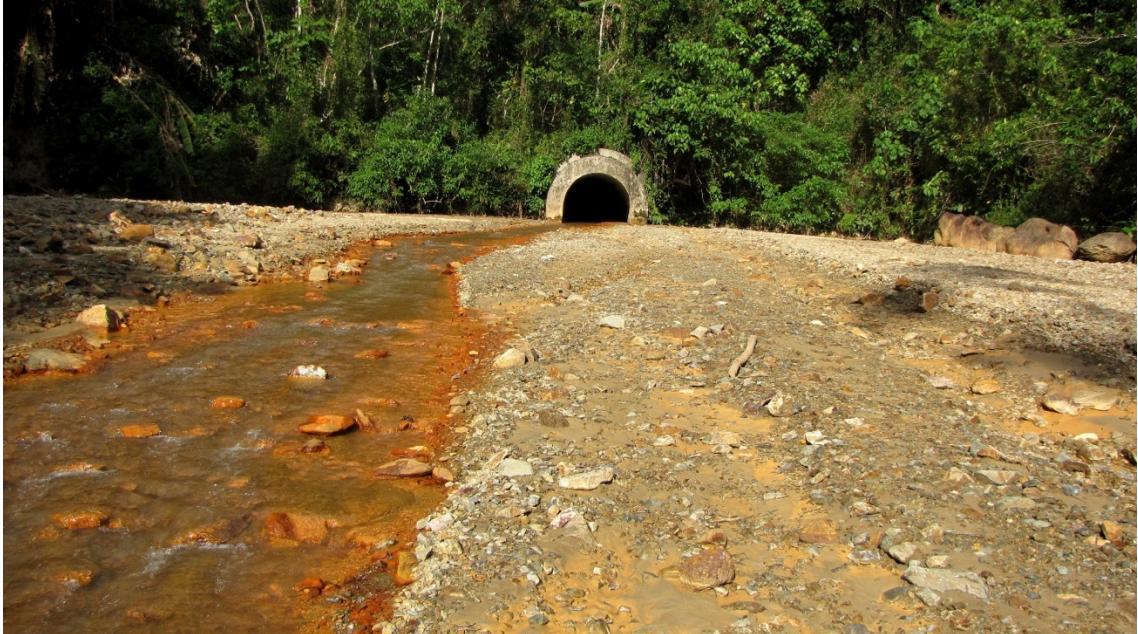
Three years after the 1993 Mogpog River disaster, the 1996 Boac River disaster occurred and the San Antonio mine ceased operations. The earthen Maguila-guila Dam has not been maintained since 1996 and has steadily deteriorated. The Mogpog River is continuously heavily contaminated by runoff from tons of overburden and waste rock at the abandoned mine site and is biologically dead.

The effluent that flows through the dam's tunnel has the bright orange colour of acid mine drainage.

Acid mine drainage flows through the Maguila-guila Dam tunnel and enters the Mogpog River. Catherine Coumans, MiningWatch Canada, 2016
